## STABILIZATION OF LOWRY RUINS

ADRIAN S. WHITE  
AND  
DAVID A. BRETERNITZ

Mesa Verde Research Center  
University of Colorado  
Boulder, Colorado

March 1976

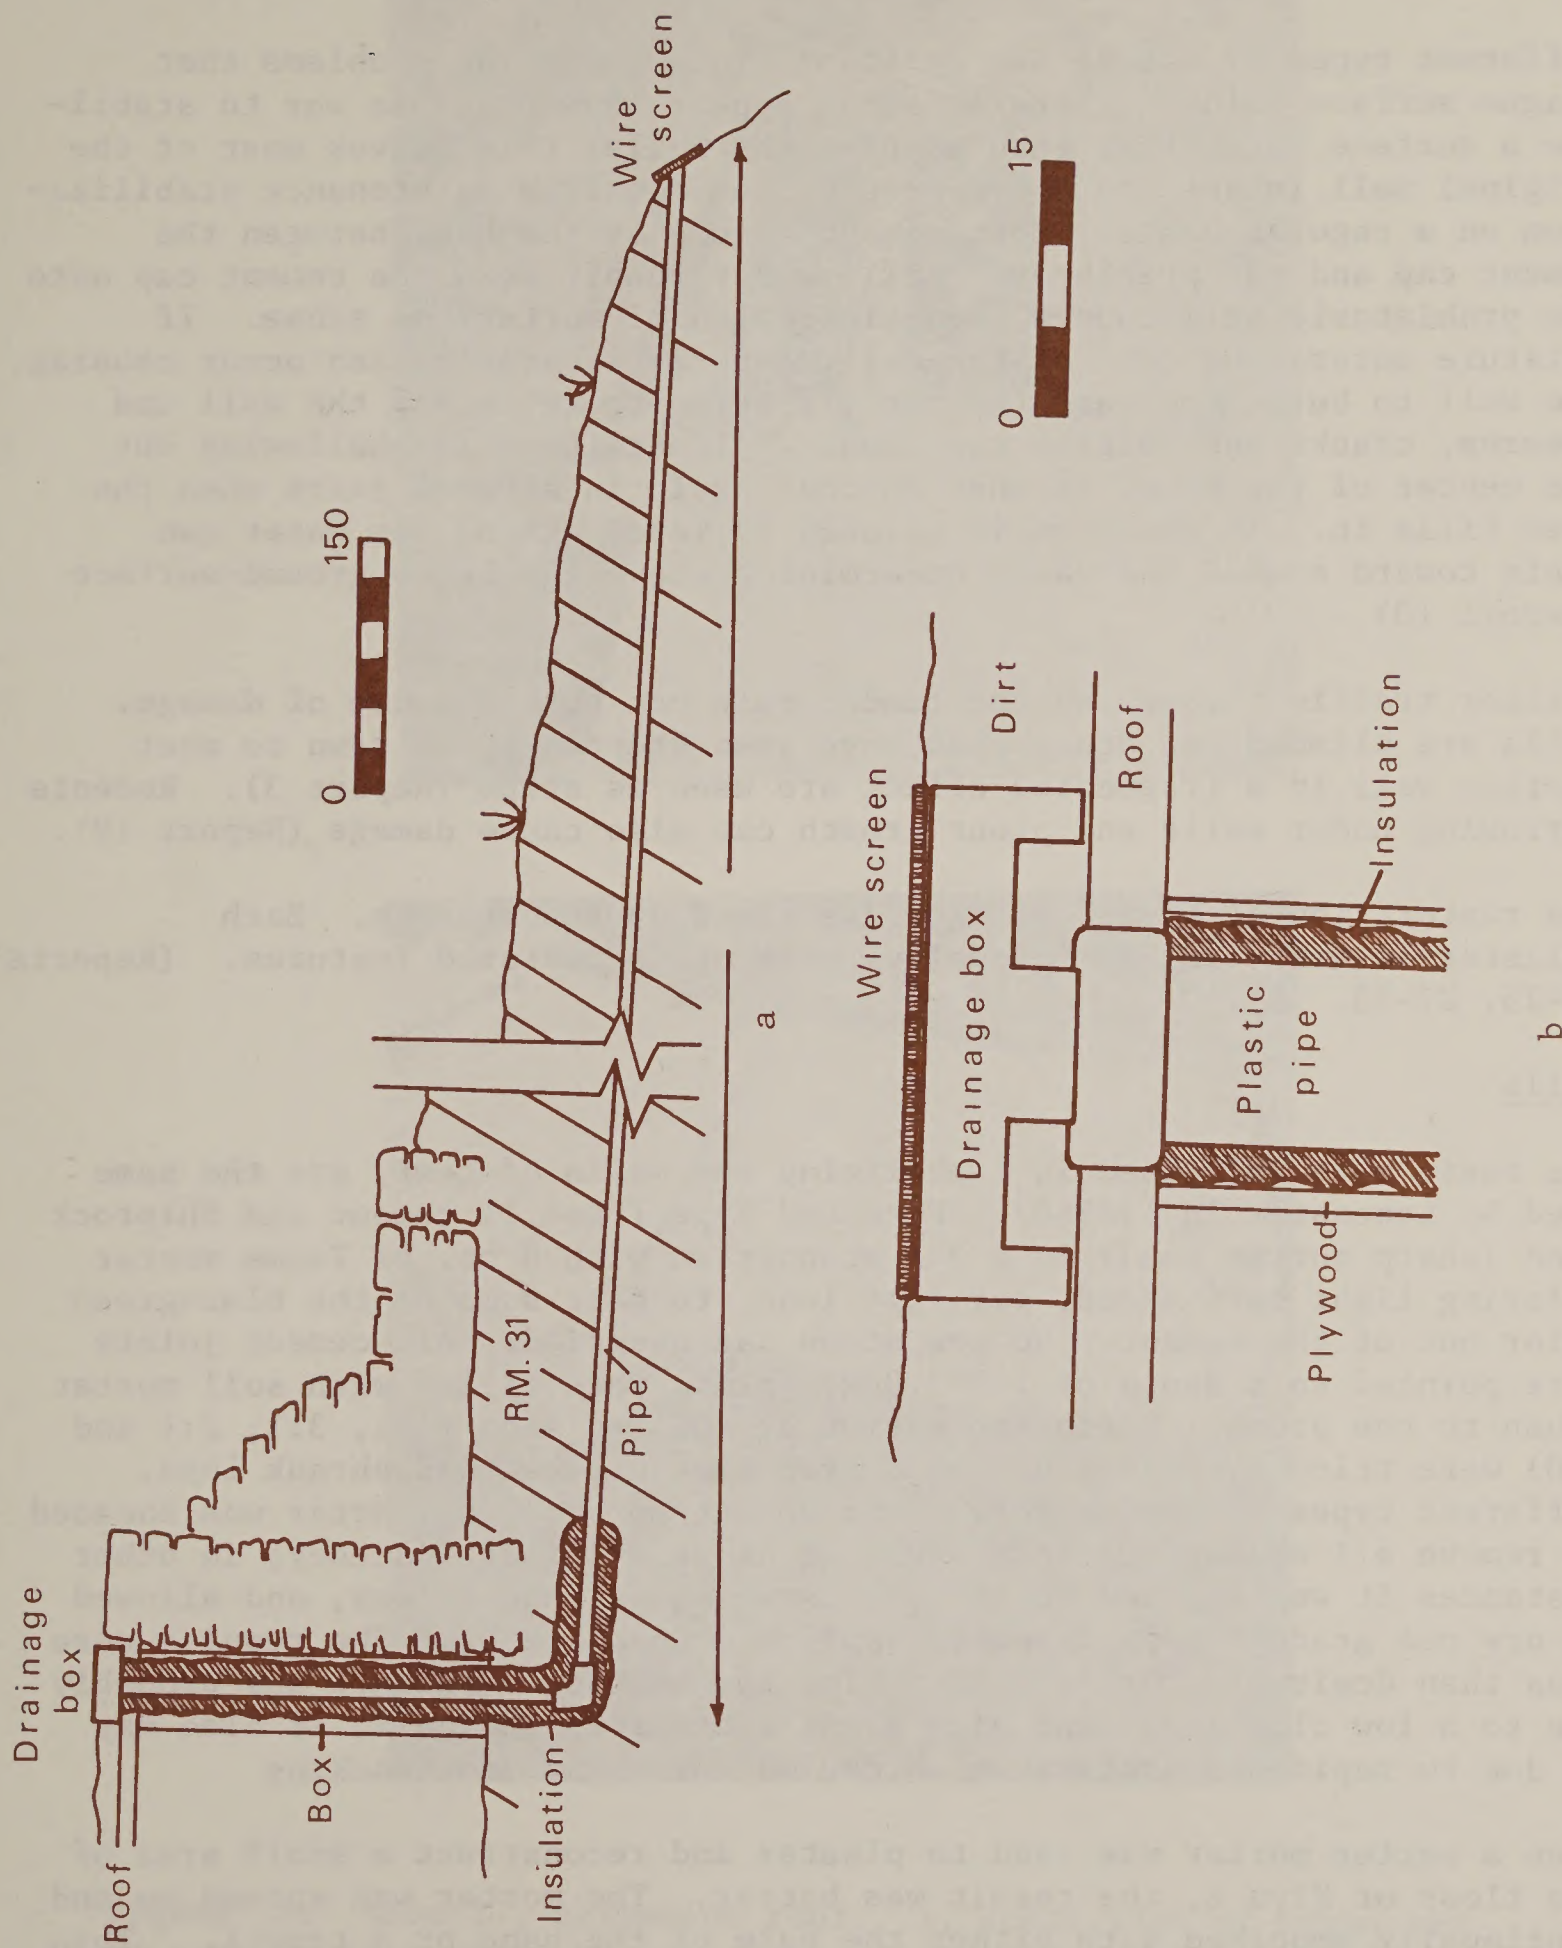
Figure 30. Kiva B, drainage system. a, east-west profile of drainage route; b, east-west profile of drainage box.

Dirt: 10-15cm of dirt were put on the roof (Fig. 29). A drainage pipe was screwed with a coupling into the southeast corner of the roof that extended 90-15cm below the surface, made a 90° turn, and extended along the north wall of Room 31 to 8m beyond the Pueblo. A drainage box was placed over the pipe into the roof (Fig. 30). The pipe was wrapped in insulation and the portion left exposed was covered with a plywood box.

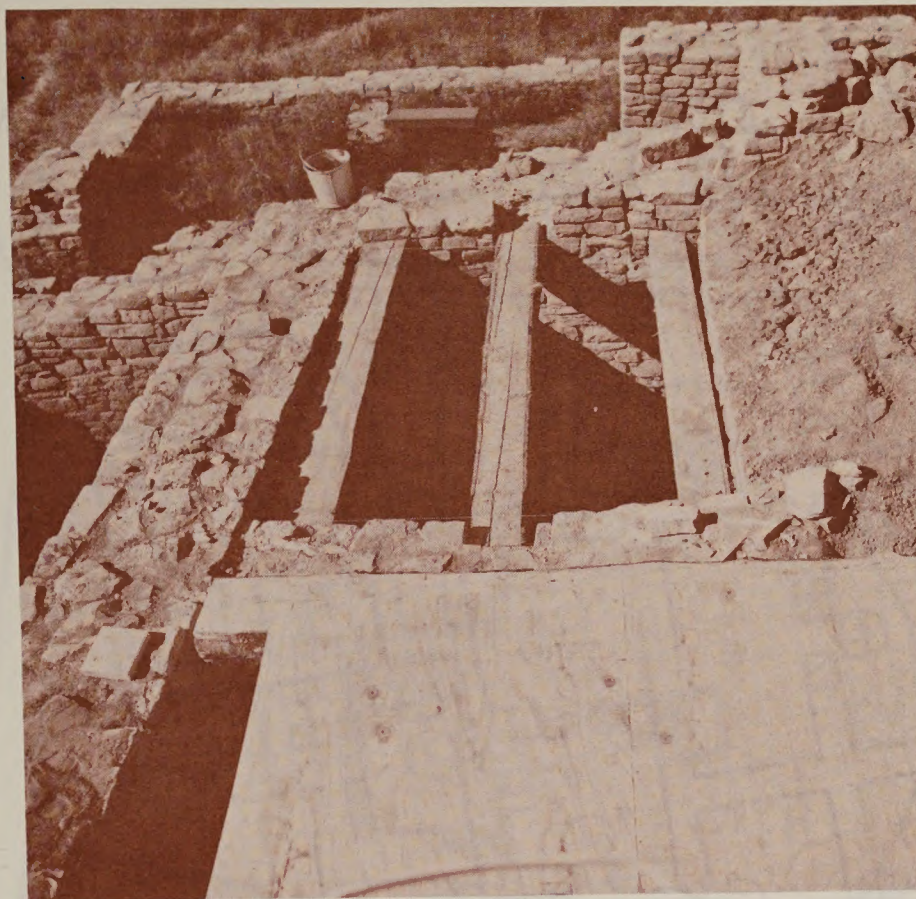
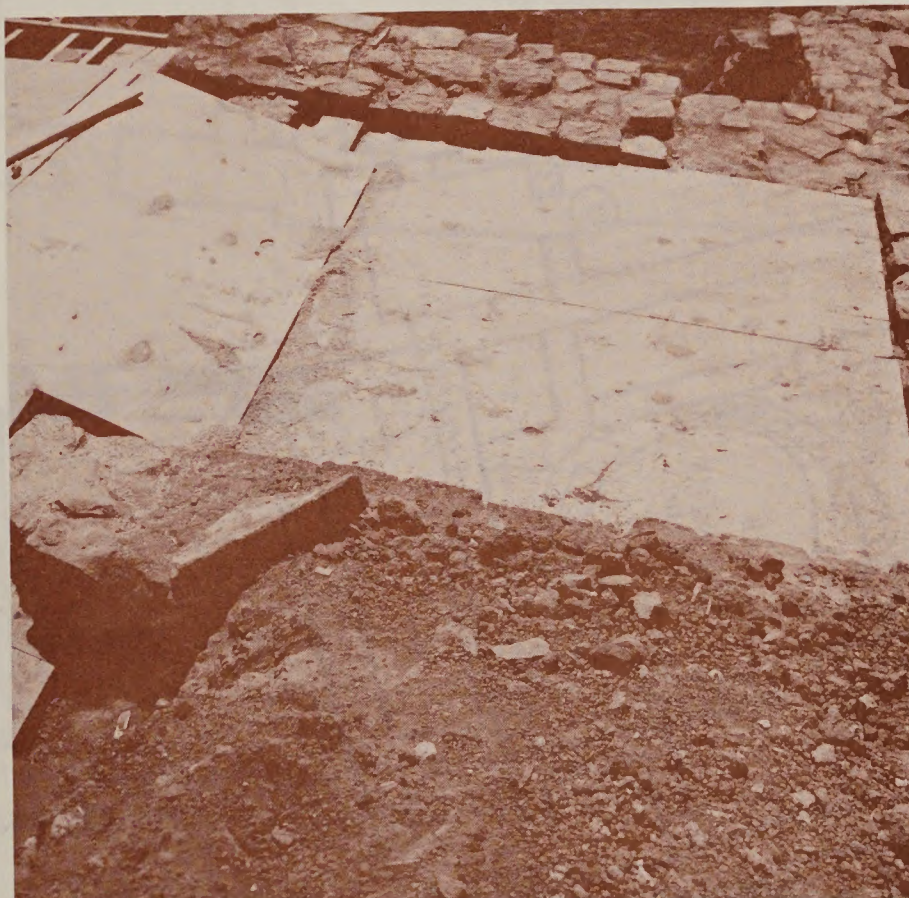
Figure 31. Room 27, permanent roof. a, south view of beams set in sockets over room; b, west view of plywood roof.

Room 27 was roofed with Kiva B. Six sockets were chiseled out of the north and south walls for the rafters to rest on; the rafters were three spruce timbers 8'6", 8'9" and 8'11" in length set in a bed of cement. Two sheets of plywood were laid directly on the beams (Fig. 31); a quarter roll of tarpaper was nailed to the nailers. A wing wall of 2" x 6" rafters connected this roof to the roof over Kiva B, making it continuous. It was covered with 10 to 15cm of dirt (Fig. 26).

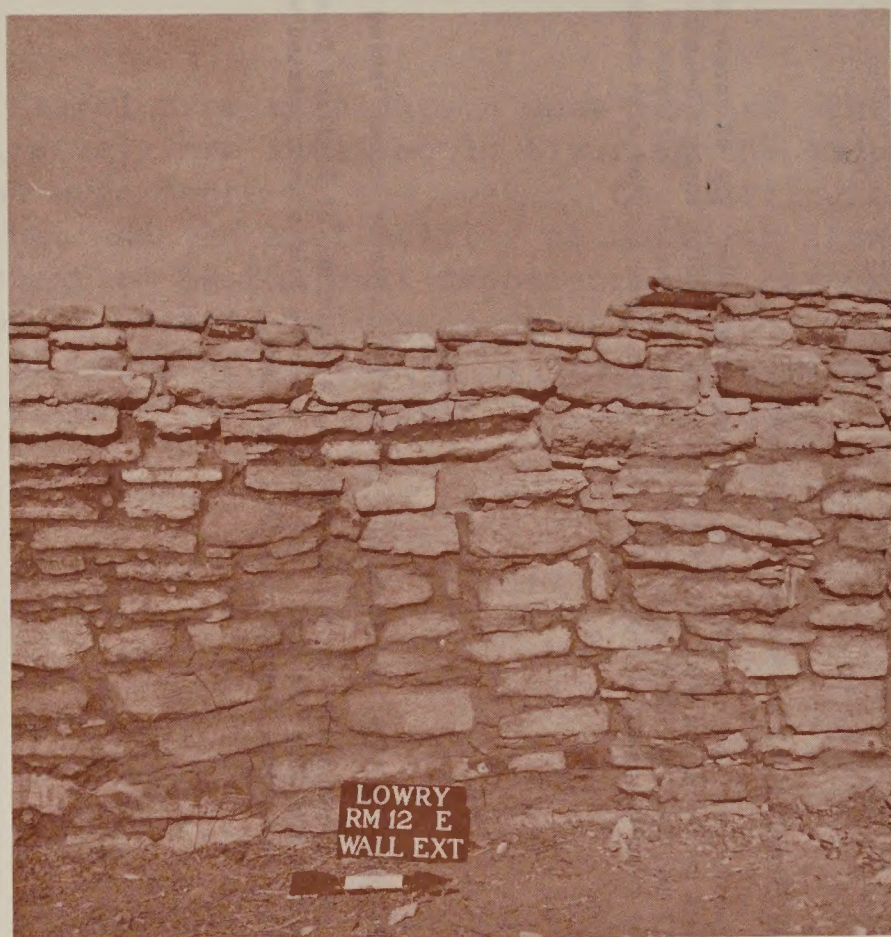
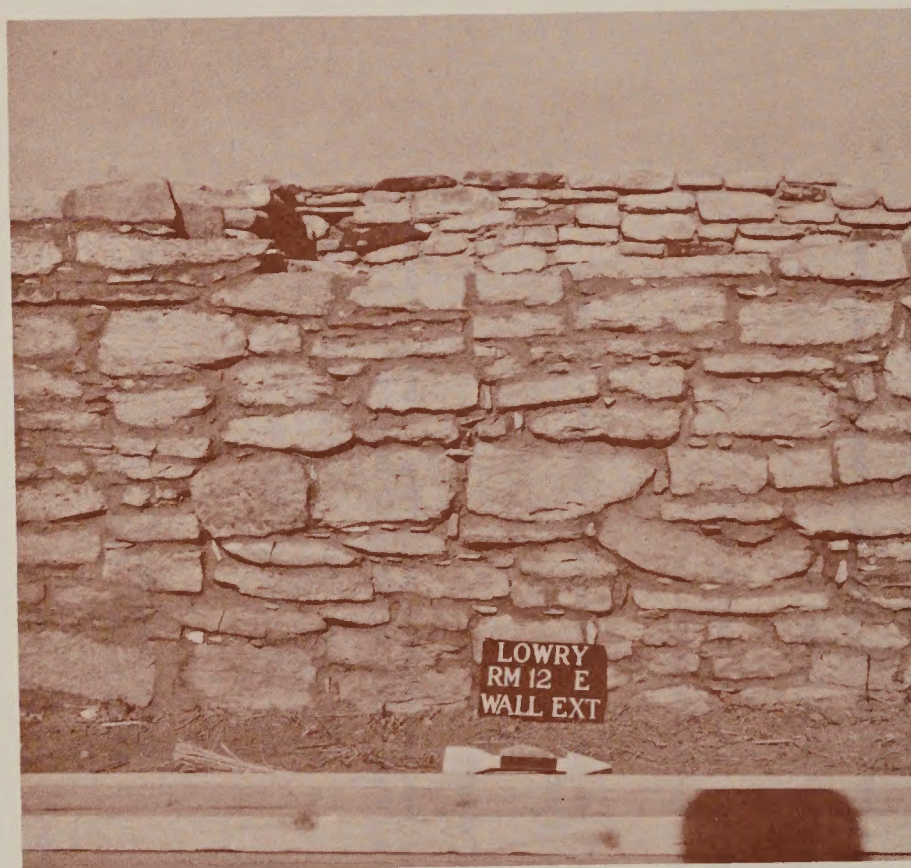
Prehistoric soil mortar and spalls had washed out between building stones leaving gaping joints. Building stones were still in line with courses showing no slumping had occurred.

Figure 34. Room 12, east exterior wall. a, northern portion of wall after stabilization; b, southern portion of wall after stabilization. No before photograph was taken; the wall can be seen in Fig. 35.

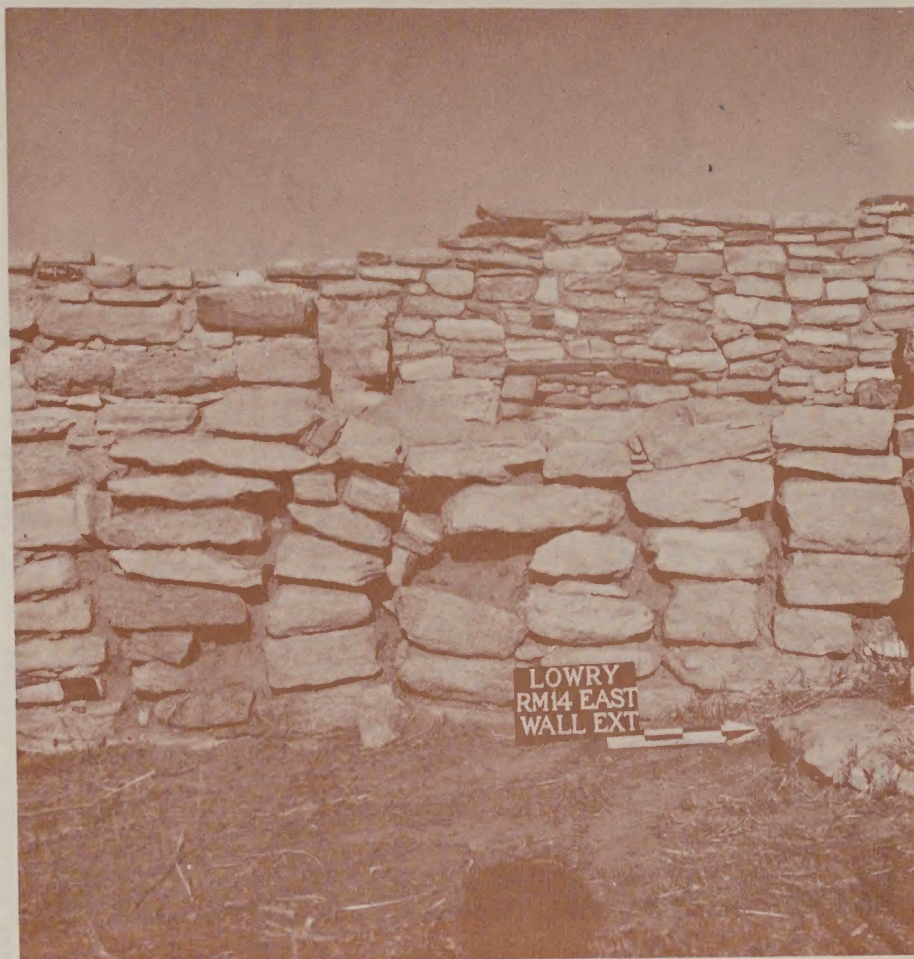
- A. The east exterior wall of Room 14 is capped on the upper 2 courses. The lower courses are composed of prehistoric masonry. Stones beneath the capped area are loose and the soil mortar is falling out and flaking off.
- B. No prehistoric masonry remains in the area of patch on the South wall of Rm. 18.

Figure 35. Room 14, east exterior wall. a, several stones were missing and large joints were created by crumbling mortar; wall was slumping at the abutment to Room 12; b, missing stones were replaced and the wall was straightened.

- A. East Ext. wall of Room 14 - all loose stones were removed and reset with a mixture of Portland cement and sand. The area reset was approx. 4-5 courses in height. Area was pointed with a soil mortar of 3 parts soil to 1 part sand.
- B. South Int. wall of Room 18 - several stones were reset with a mixture of Portland cement and sand.

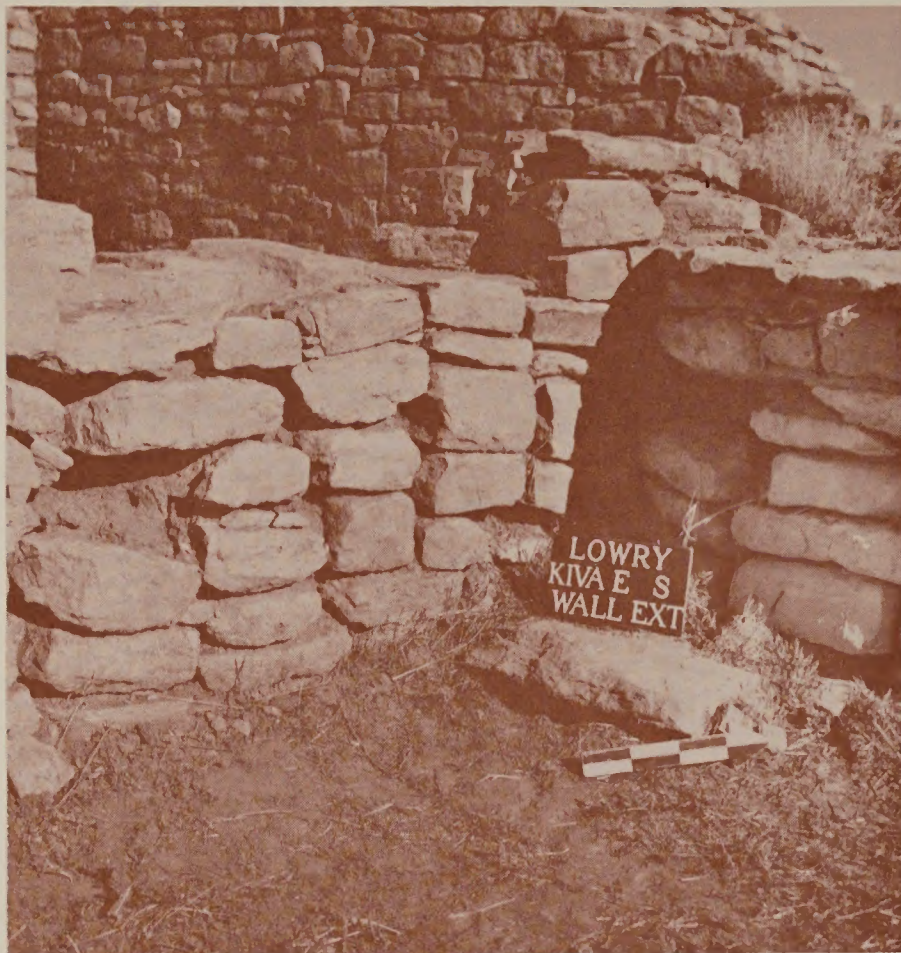
- A. Building stones had fallen in central area of wall from the 3rd to 8th courses. Soil mortar was in a crumbling state with stones loosened and several missing. Large joints were created by missing joints.  
B. No prehistoric masonry remained, entire SE corner of this wall was set in cement in 1966.

Figure 36. Kiva E, south exterior wall. A, several stones were missing and large joints were created by crumbling mortar; b, stones were reset and all large joints were filled.

- A. All loosened stones were removed along with all loose soil mortar. Stones were reset with a mixture of Portland Type I and II cement and Shiprock sand. All newly cemented joints were pointed with soil mortar of 2 parts soil to 1 part sand.  
B. Loosened stones were removed and reset with mixture of Portland cement and Shiprock sand. Area was pointed with soil mortar of 2 parts soil to 1 part sand.

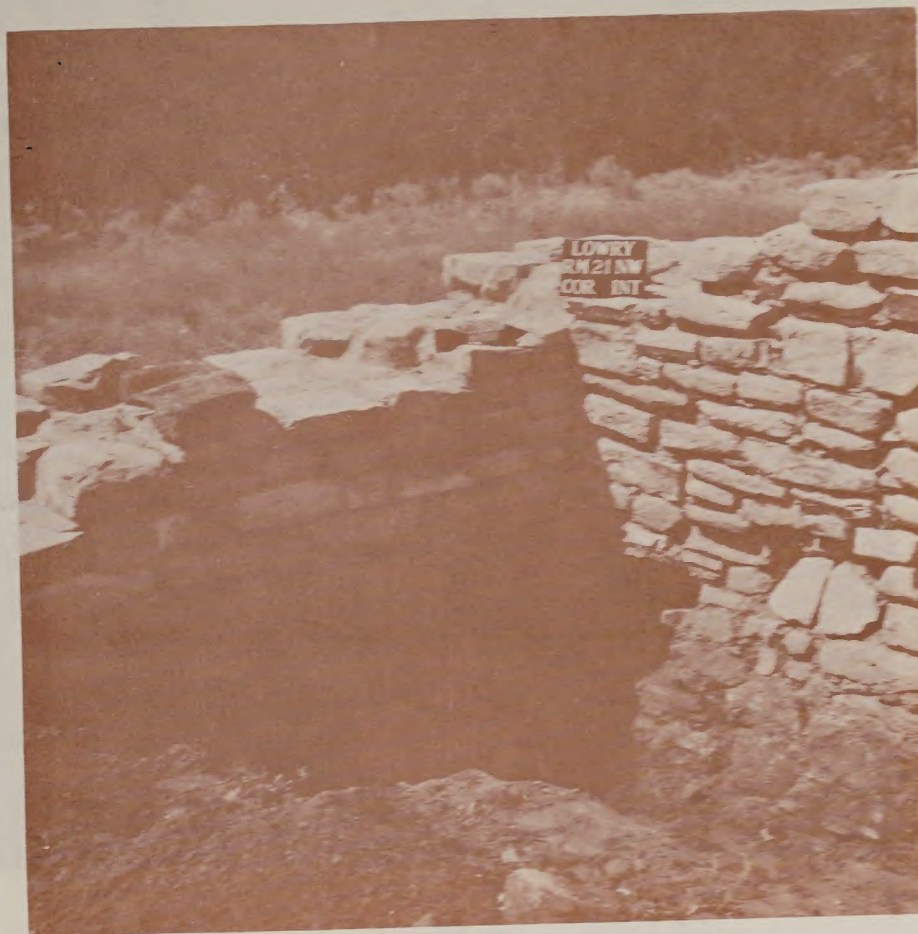
Corner of Rm. 21 showed cracking of soil mortar and concrete prior to trench being dug along wall below soil level of room. The trench showed intensive erosion had occurred in the portion of wall below soil level. A large crack ran between the 5th and 6th course. Overall view of wall indicated wall was slumped outward and downward.

Photograph taken before reconstruction shows area involved in erosion after dirt was cleared from lower courses of wall. Previous to being cleared this corner showed severe cracking of concrete and loosened slabs with several areas showing stones completely missing.

Figure 38. Room 21, northwest interior corner. a, large area of missing and fallen stones caused by undermining; b, stones were reset and pointed with soil mortar, soil was banked against the wall and sloped towards the center of the room.

Corner was stabilized by removing loose stones and soil mortar to a height of 6 courses and resetting reused stone with a mixture of Portland Type I and II cement and sand. Entire area cemented was pointed and spalled with a mixture of soil mortar of 3 parts soil to 1 part sand.

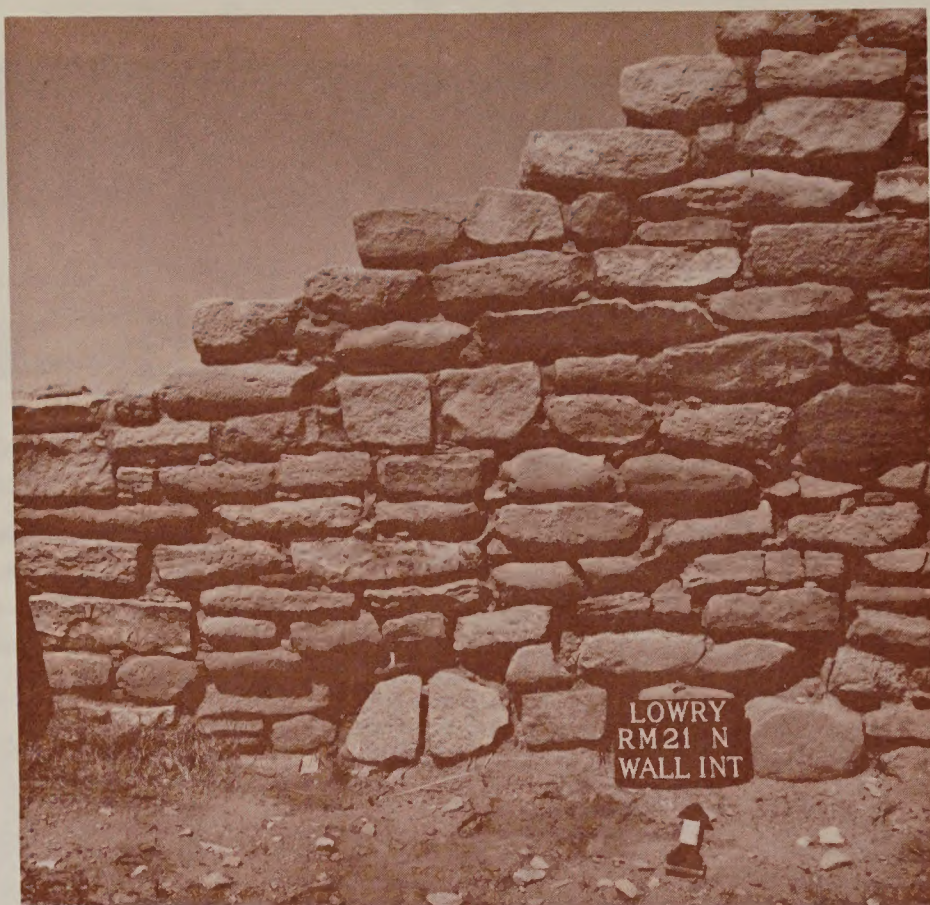
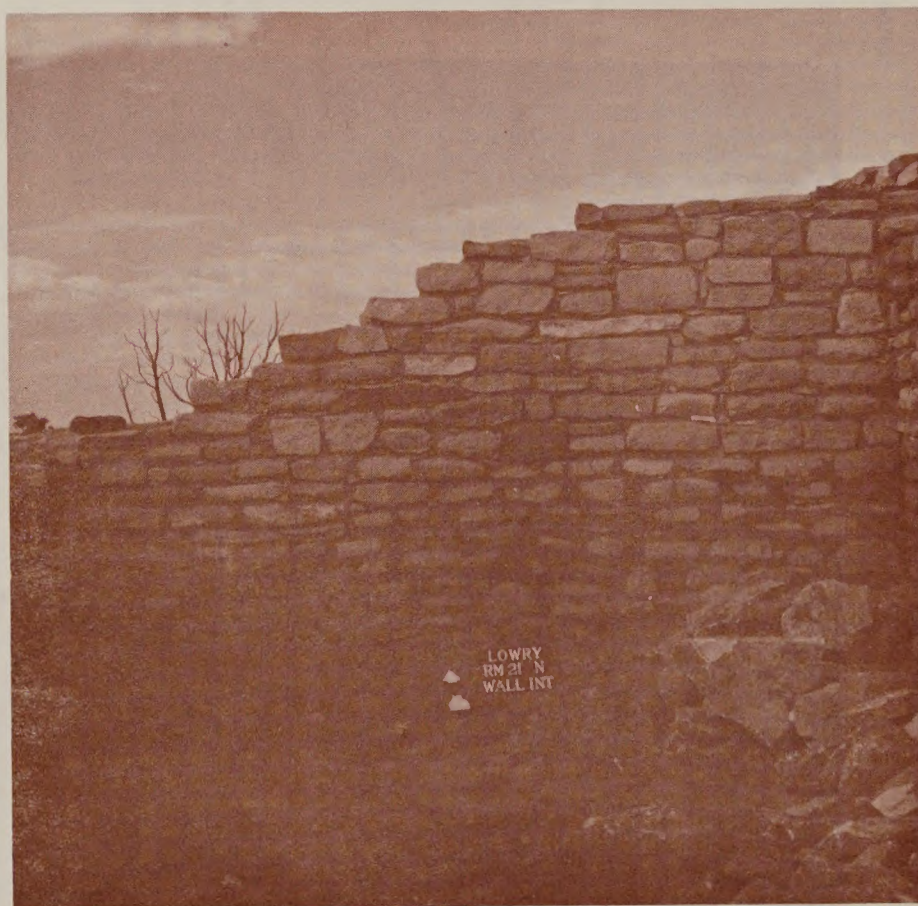
Figure 38. Room 21, north interior wall. c, damage included fallen stones and large joints; d, all loose stones were reset and large joints were pointed with soil mortar.

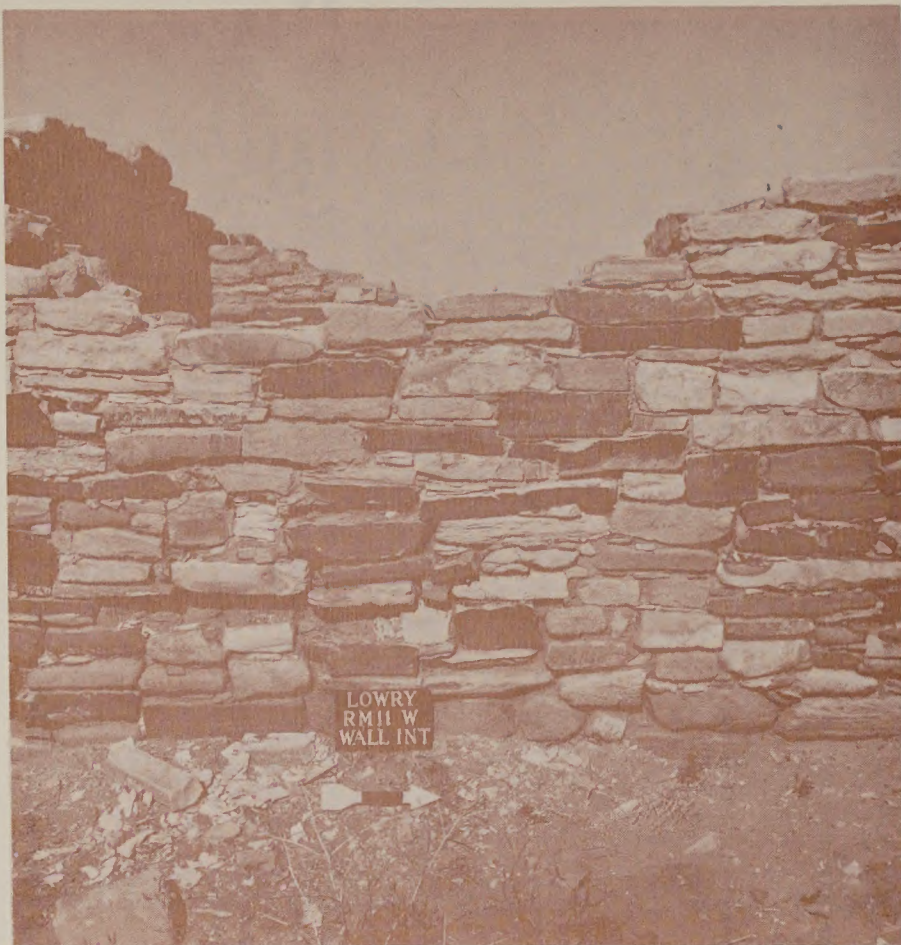
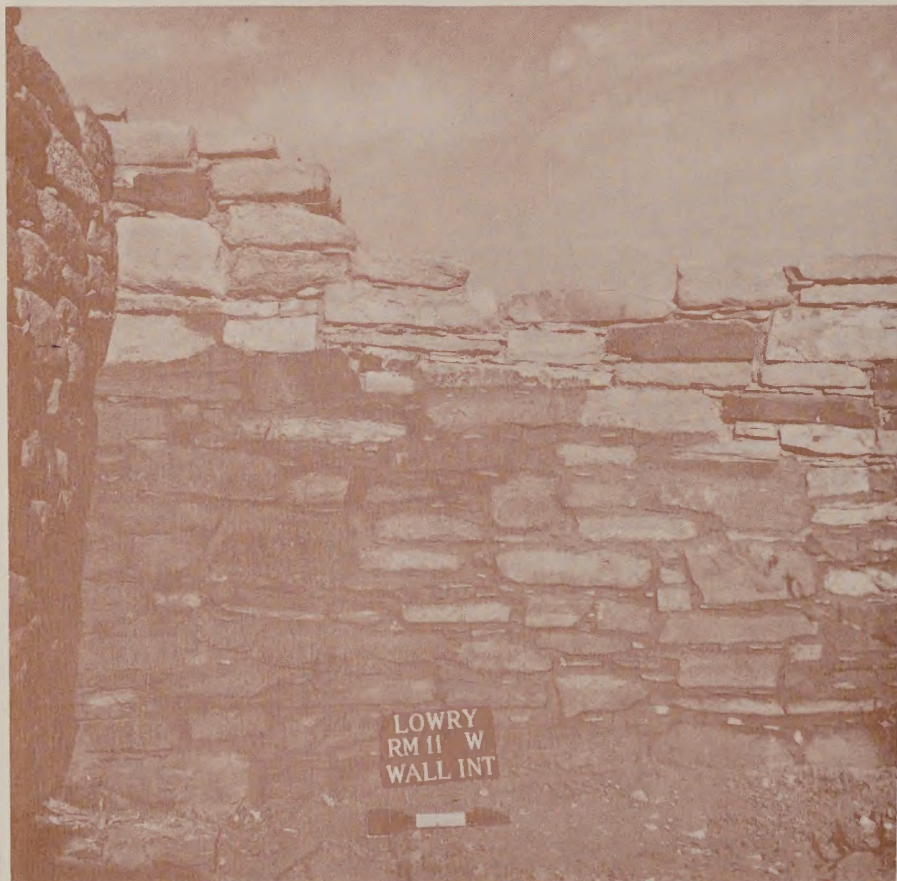
Middle area of wall was eroded, soil mortar was flaking off in chunks with several stones in middle of wall completely missing.

Photograph taken before restoration shows eroding sandstone slabs with several missing in the middle area of wall. This wall is built of a different type of sandstone not common at this ruin.

Figure 39. Room 11, west interior wall. a, several stones had fallen from wall and stones of soft sandstone were eroding; b, eroding and missing stones were replaced.

Loosened stone and eroding mortar was taken out of wall and stone was reused with mixture of Portland cement and Shiprock sand. A soil mortar mixture of three parts soil to one part sand was pointed into cement joints. Since this wall showed evidence of spalls prehistorically, spalls were pressed into joints of soil mortar to match up reconstructed wall to prehistoric wall.

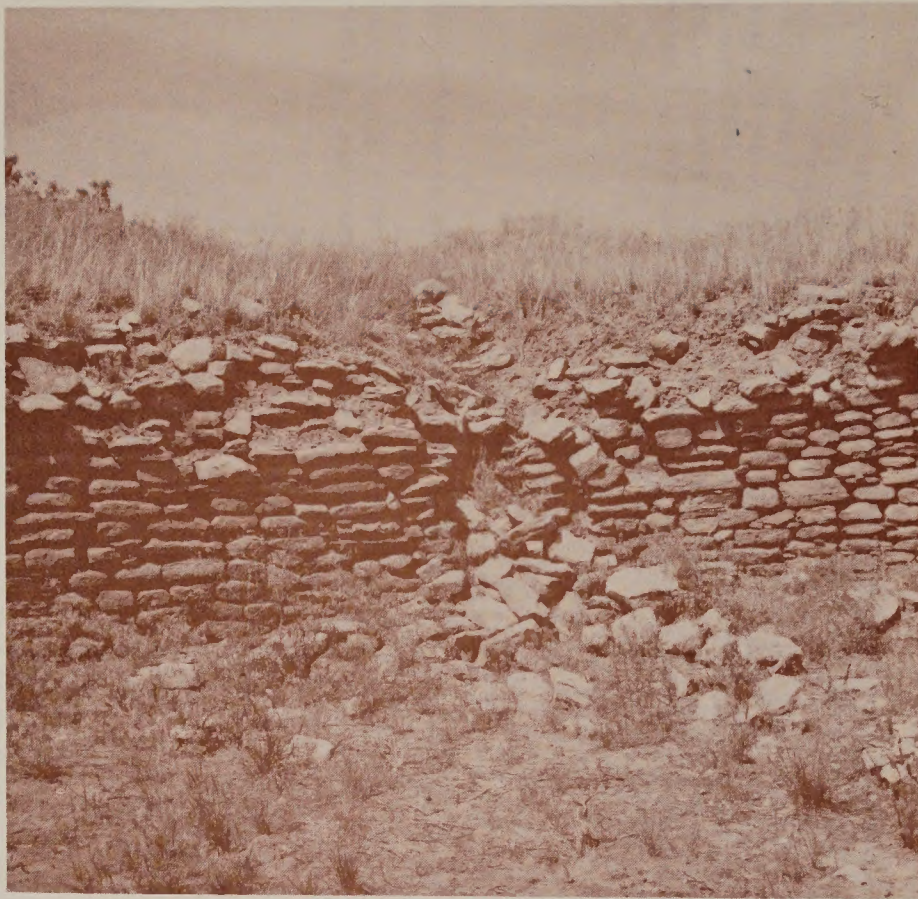
Photographs taken before stabilization show extent of damage in four different areas. Three of these areas were small repair jobs of 1-3 stones which were loosened or slipping from banquet wall. The other area involved the stairway. The damage here was due to runoff from ground level into Kiva.

Figure 40. Great Kiva, stairway. a, stairway before stabilization in 1966; b, water runoff down stairway caused erosion behind wooden post steps.

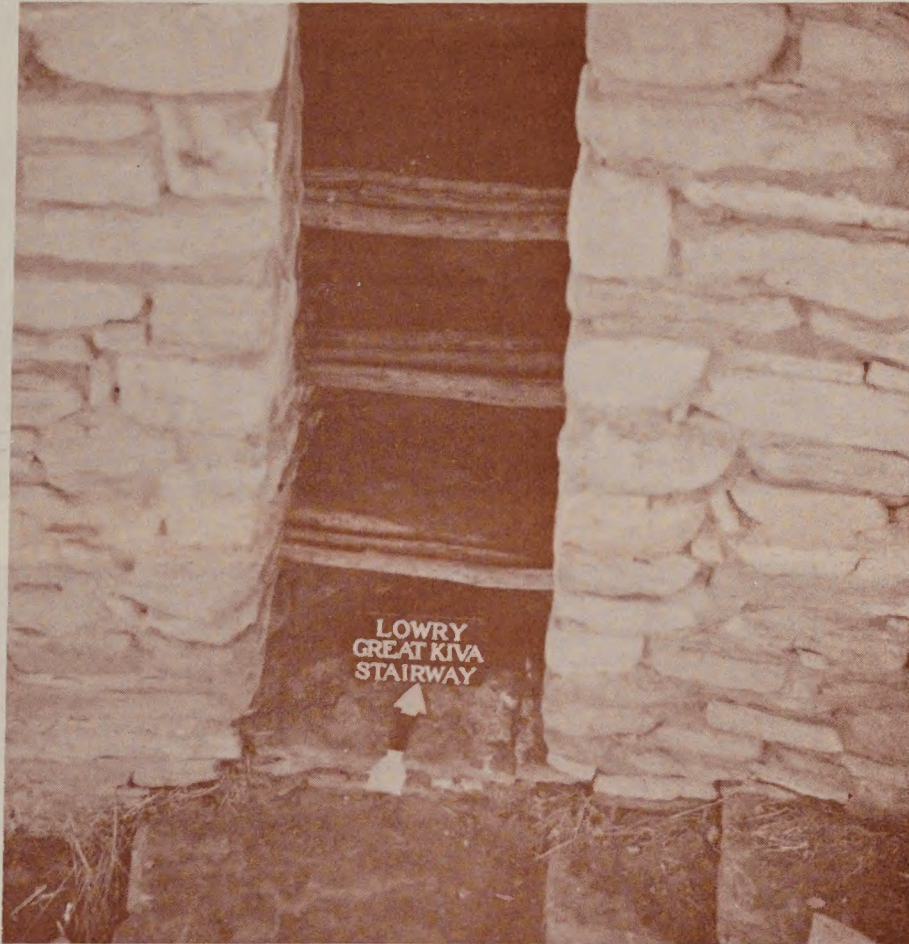
Figure 40. Great Kiva, stairway. c, stones behind wooden post steps were reset.

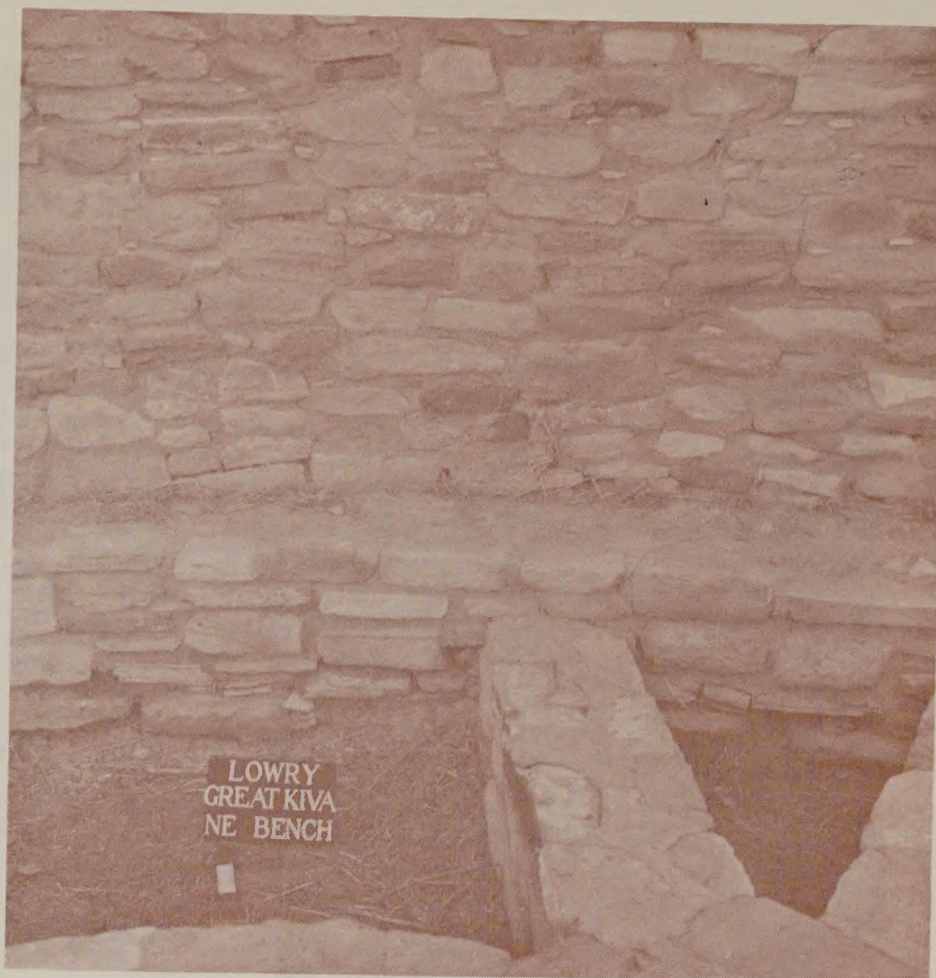
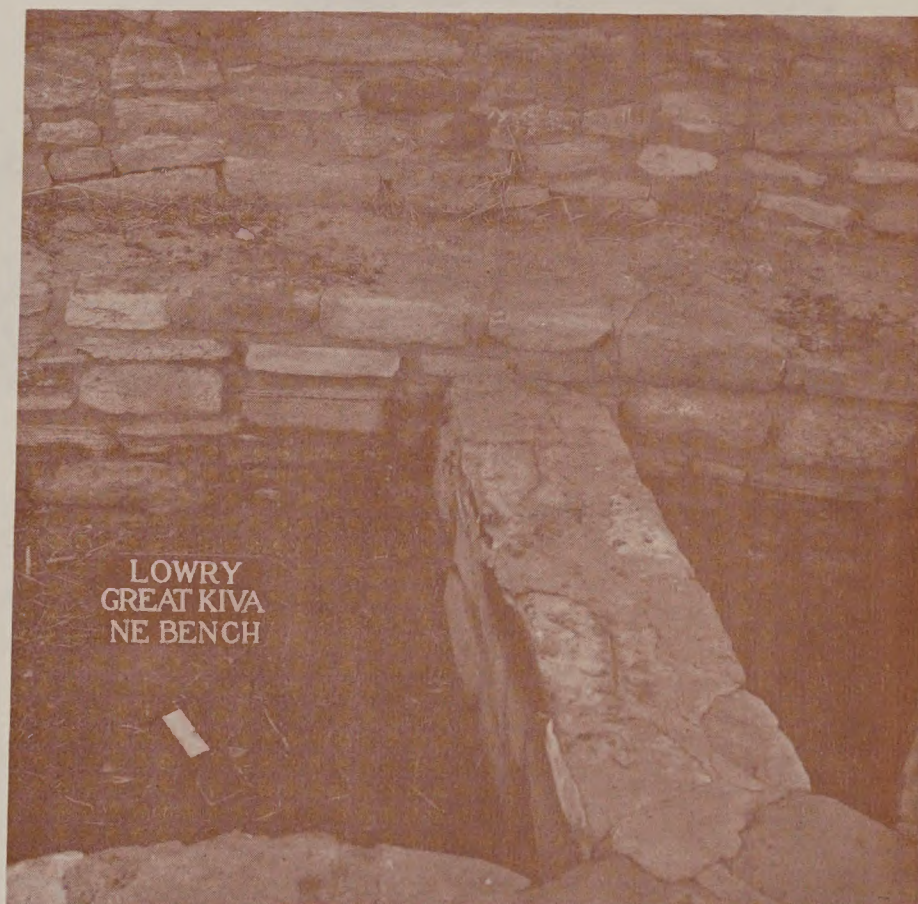
Figure 41. Great Kiva, northeast bench. a, mortar eroded beneath cement cap leaving large joints; b, all joints were grouted with soil mortar.

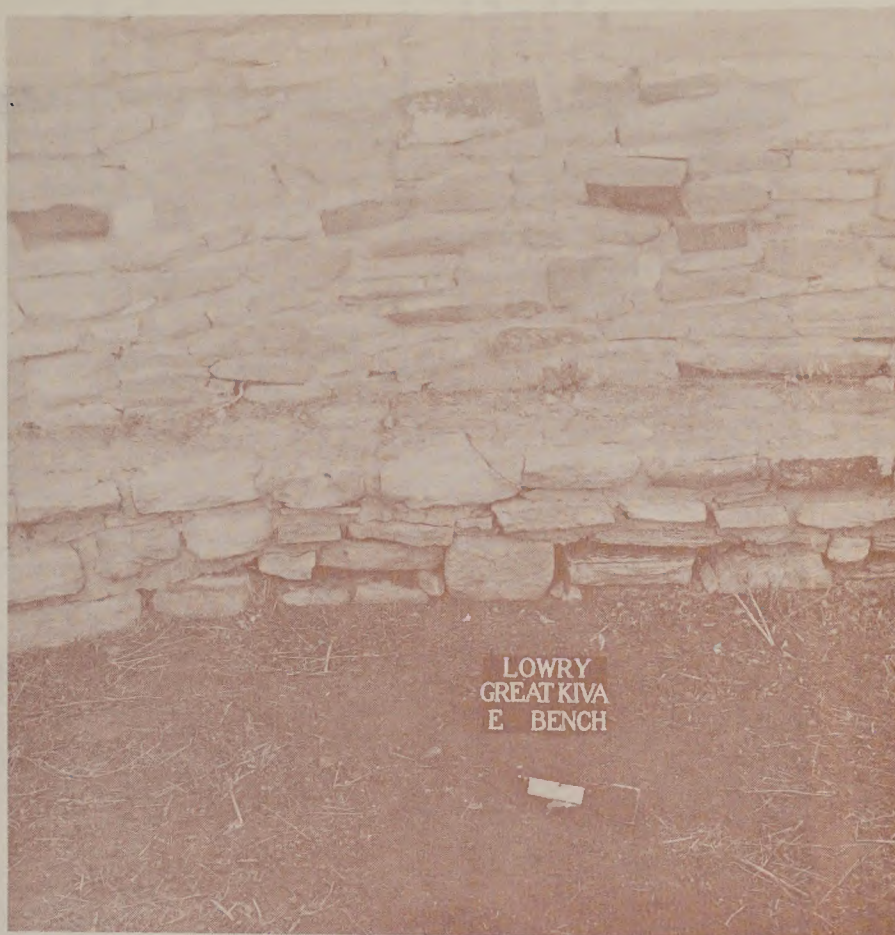
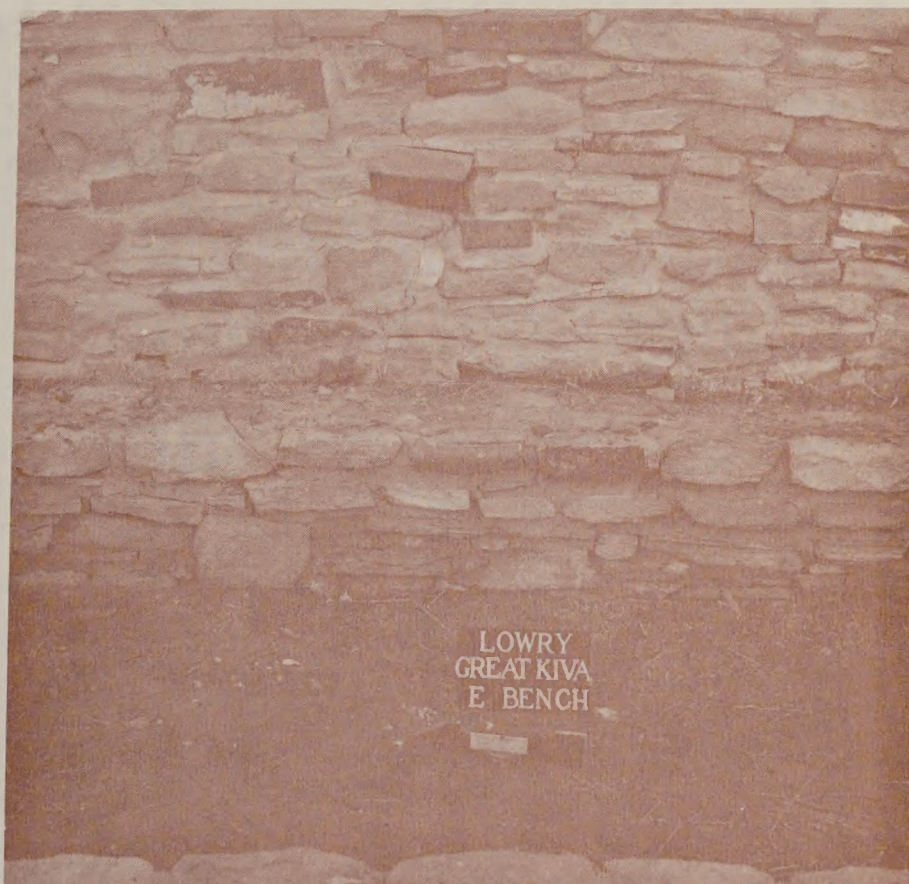
Figure 42. Great Kiva, east bench. a, mortar eroded beneath cement cap leaving large joints; b, all joints were grouted with soil mortar.

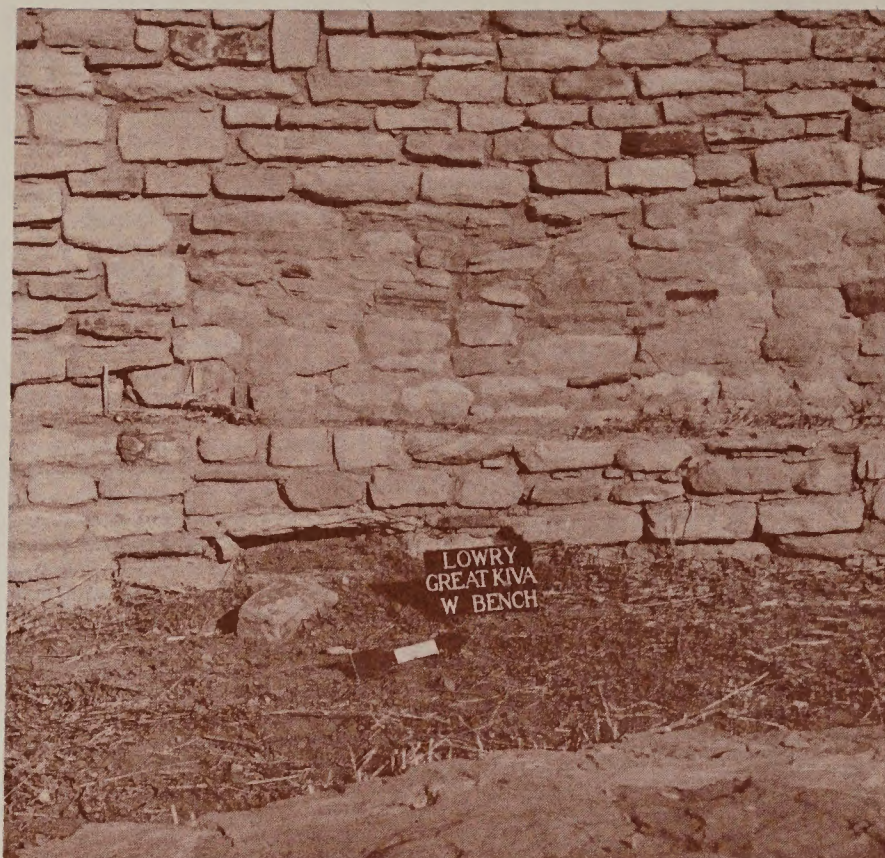
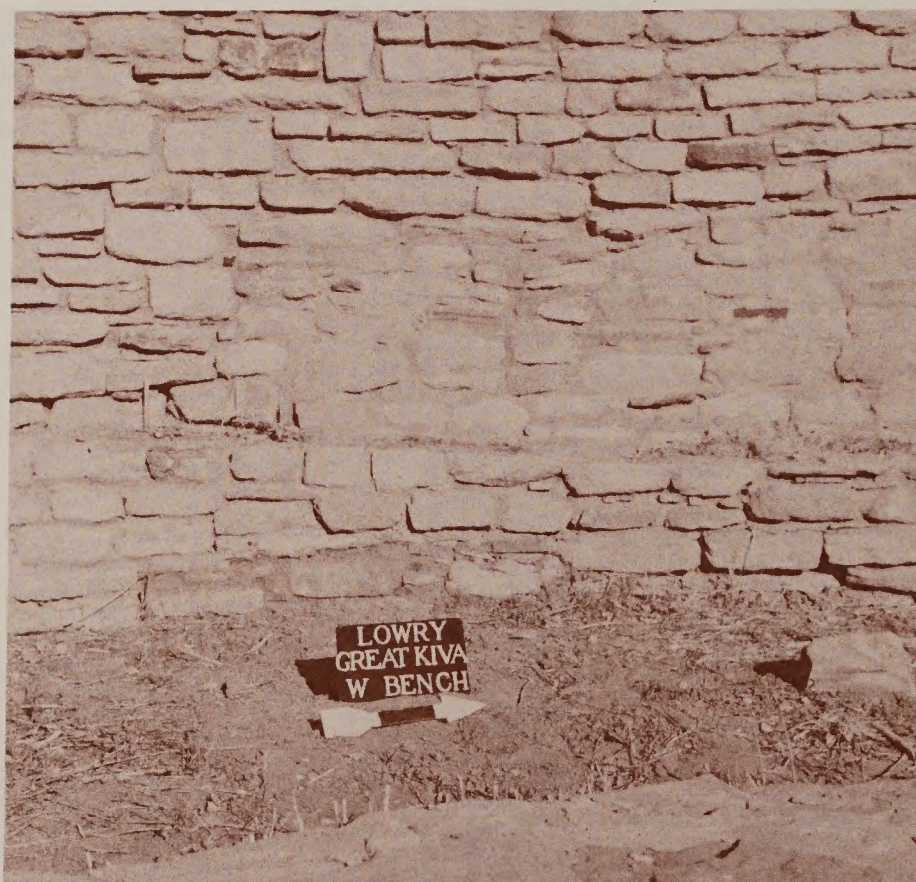
Figure 43. Great Kiva, west bench. a, one building stone was missing from bench wall; b, stone was reset and large joints were grouted.

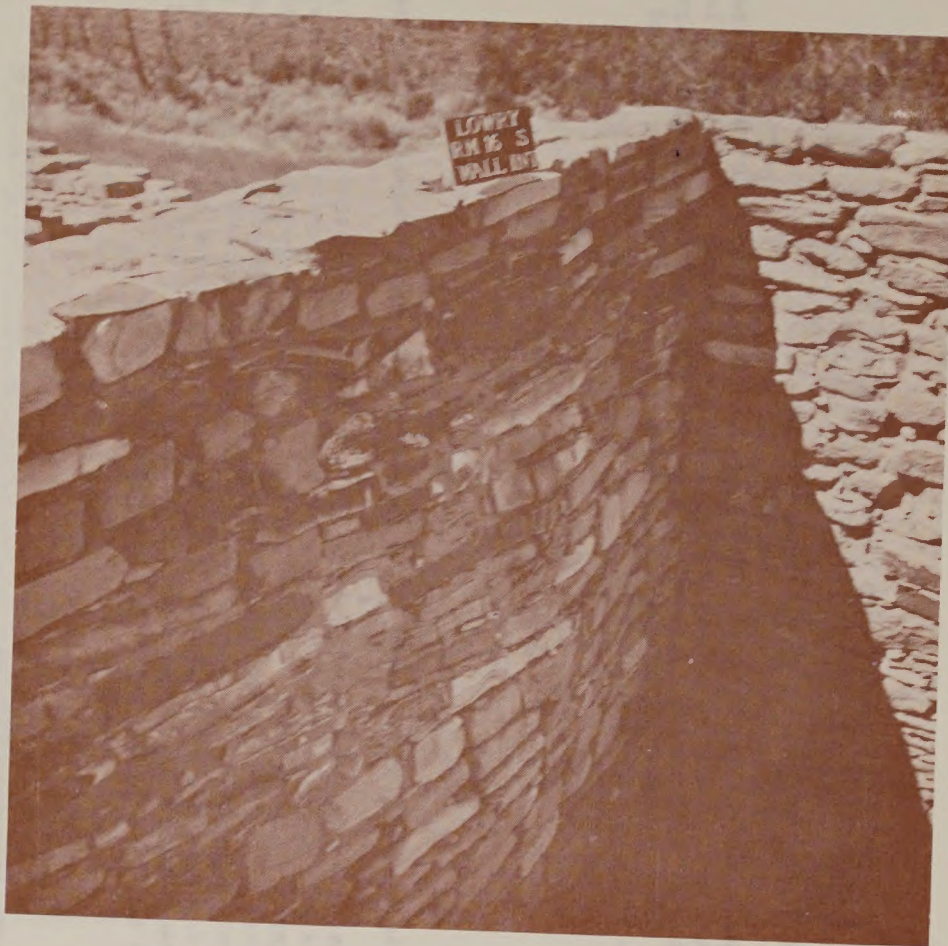
This wall was reconstructed in 1967 by Al Lancaster. At that time it was noted that the wall had an extensive bulge in the central area of the S interior wall. However the deciaion was made to cap top three courses and to leave bulge as it was. Other restoration of this wall involved large joints being grouted with cement.

Figure 44. Room 16, south interior wall. a, lateral separation caused wall to bulge outward; b, view of exterior side of wall shows that damage did not extend through the thickness of the wall.
